# National Register of Historic Places Registration Form

historic name Benson Historic Barrio

street & number 307-572 Fifth Street, between San Pedro Street and Route 80

city or town Benson

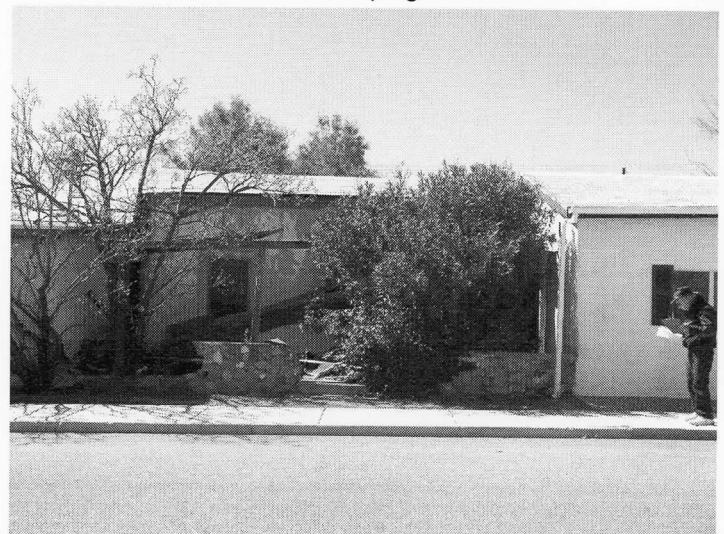
**Photo 4.** 478 E. Fifth Street. This transitional, side-gabled massed-plan dwelling is placed so that its walls abut those of its neighbor, a Mexican settlement trait. 464 E. Fifth Street, next door, is placed very close to the front property line.

Another very old, side gabled, linear-plan dwelling of the "transitional tradition" is 478 E. Fifth Street on Block 24 (Photo 4). Built around 1905, it abuts its neighbors on either side. The vacant dwelling is in very poor condition today and its full-width frame porch (showing on the 1931 Sanborn Map) has completely collapsed. It is not known whether the dwelling originally had a flat roof. Currently it has a side-gabled roof with roll composition roofing.

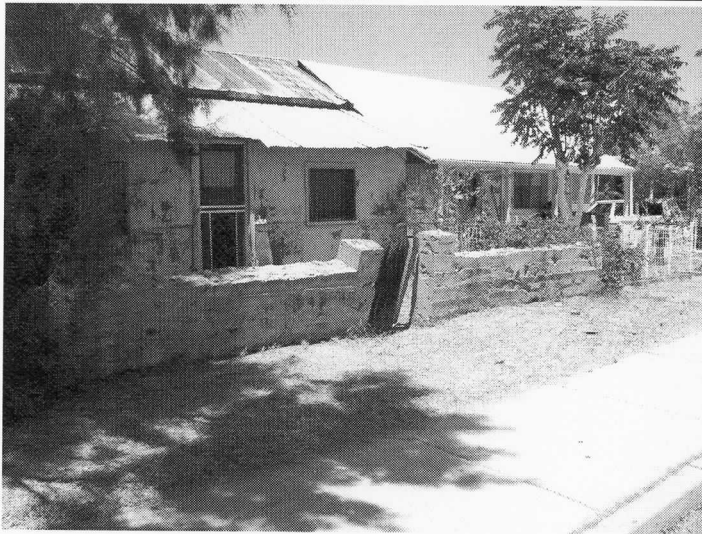
**Photo 5.** Unique, hand-poured wall marking the front property line of 371 E. Fifth Street. Note also the green painted house walls. Both the garden wall and the pastel color of the house walls are Mexican cultural traits.

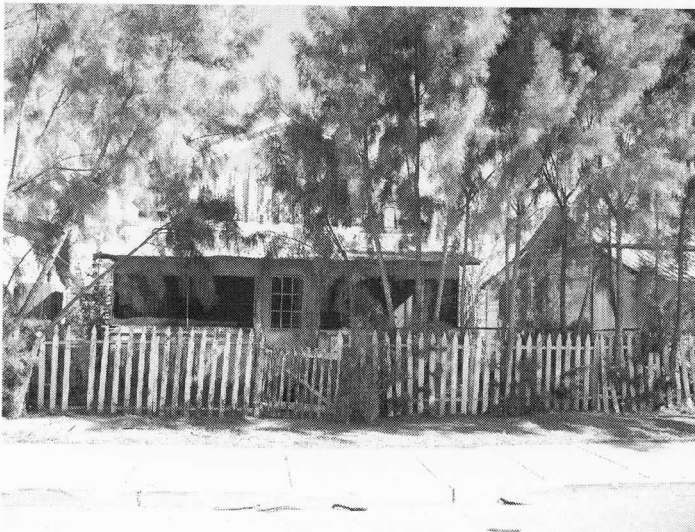
**Photo 7.** 369 E. Fifth Street. A 1900 "railroad house" west of Gila Street. This is a gable-front, massed-plan dwelling, a Euroamerican vernacular type. Built of frame, it may be an example of "box construction."

In the Barrio, the earliest contributing dwellings of this type are found side-by-side on Block 19 at 351 and 369 E. Fifth Street (Photo 7). These "railroad houses" were built in 1900 to accommodate employees of the Southern Pacific Railroad. They are Greek-Revival influenced due to their temple-front shape and gable cornice returns. Both houses have wood, double-hung windows and full-width, drop-shed, front porches on wood posts.

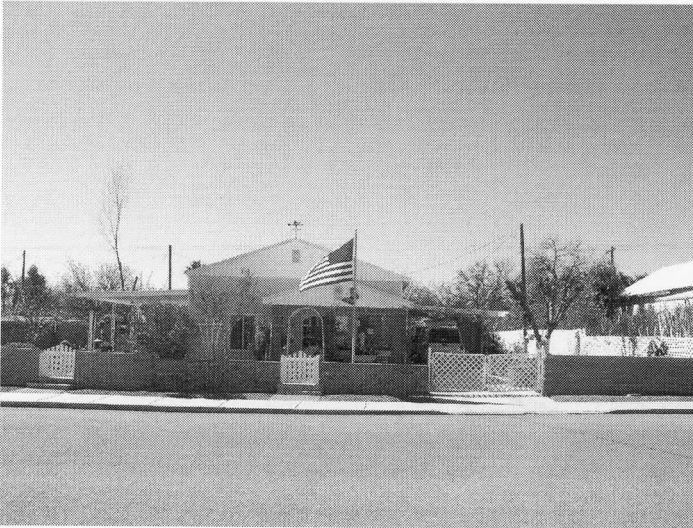
**Photo 9.** 418 E. Fifth Street, the Ellsworth House. This gable-front, massed-plan dwelling acquired its current form and front porch through a 1950s remodel of the original ca. 1900 adobe walls. The siding is painted a vibrant mint green color.

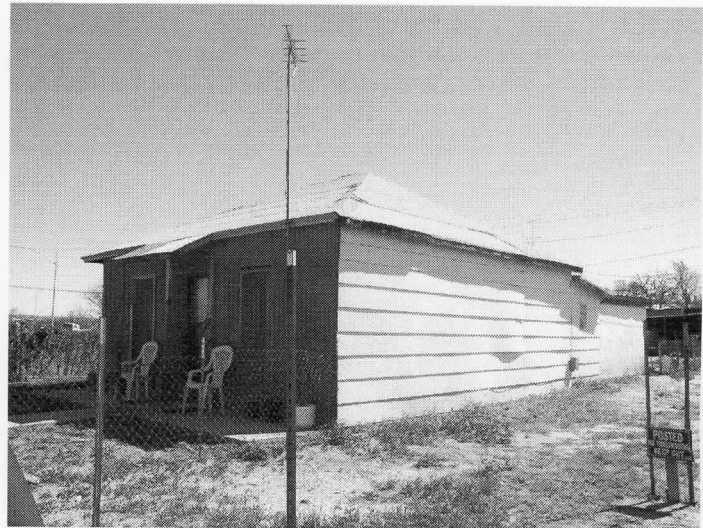
**Photo 10.** 550 E. Fifth Street. This is a classic pyramidal cottage built in 1930 of stuccoed adobe. The west wall has blue, horizontal, composition siding.

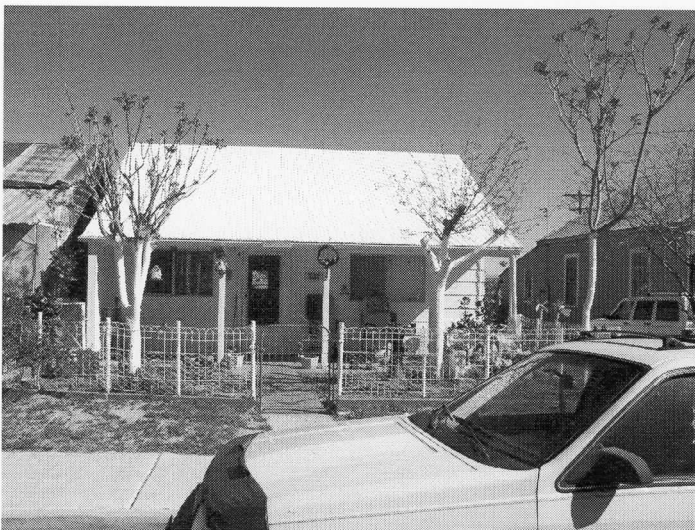
**Photo 11.** 387 E. Fifth Street. A second generation "railroad house" built in 1925. This is a side-gabled linear-plan type with shed additions to the rear.

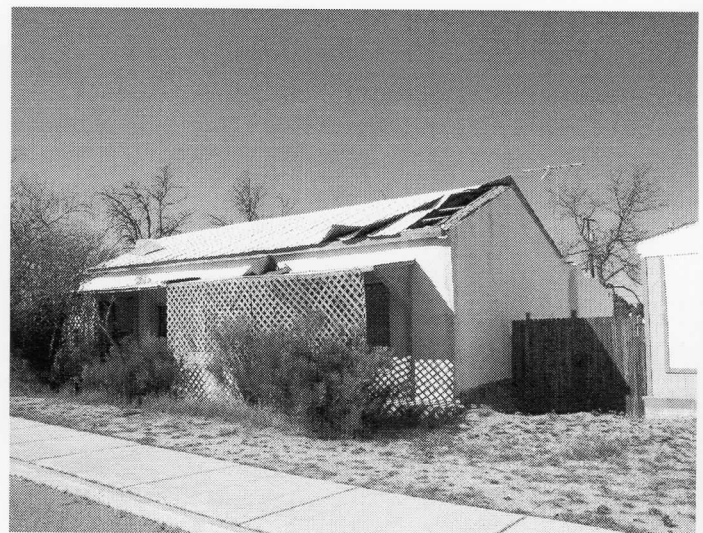
**Photo 12.** 463 E. 5<sup>th</sup> Street. The 1900 Genaro Figueroa house was originally a Sonoran, parapet-walled, flat-roofed dwelling. It was later transformed by the addition of a pitched roof, exemplifying the "transitional" tradition.

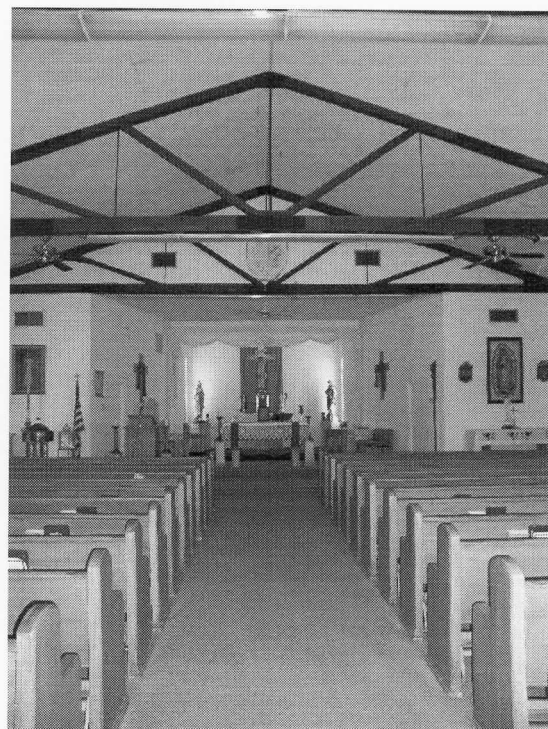
**Photo 14.** Interior of Our Lady of Lourdes Catholic Church. View towards altar showing trusses and oak pews.

The interior of the sanctuary is simple and noteworthy for its dark stained wood trusses and simple stained glass windows individually donated. The pews are of oak (Photo 14).

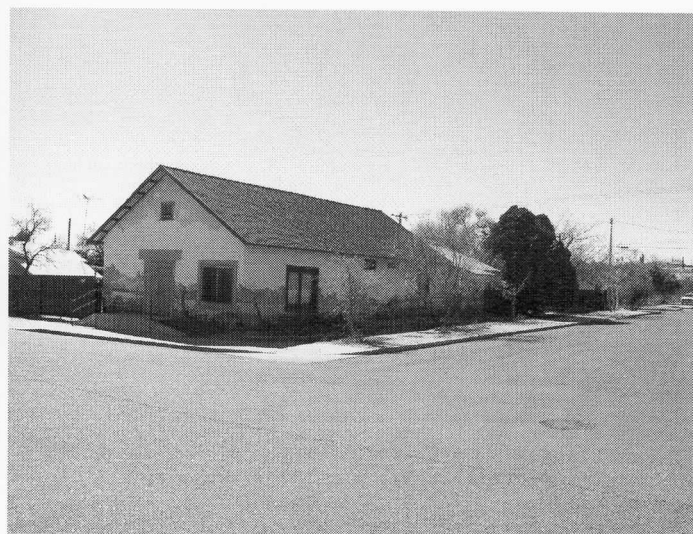
**Photo 16.** Original Quihuiz Grocery Store, built in 1925. Owned and operated by the Quihuiz family who resided in back. Unusual for a corner commercial building is its elongated, gabled form.

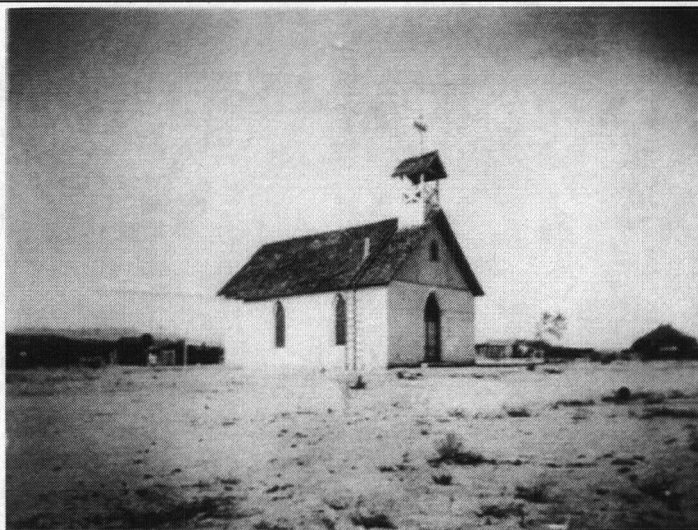
**Photo 22.** Our Lady of Lourdes Catholic Church, first building. Built on Block 25 in 1895, this modest, Gothic Revival-influenced adobe church served Benson and surrounds and as the heart of the Barrio, probably around 1895.
